# A Tubular Hydro-Generator Through Bolts Failure Analysis

**Abstract:** After running for several years, in the maintenance of a tubular turbine, many through bolts melted, and fatigue fracture, insulation damage were found. First, an analysis is done. Then simulation calculations are done to investigate the additional losses and the electromagnetic force acted on the through-bolts. Finally, the modal is analyzed. The results show that after long-term operation, under the action of the electromagnetic force vibration, fatigue, deformation, short circuit to stator core is formed with key bars, and a lot of heat is generated. That' s the reason how the accidents occur. At last, treatment suggestions are proposed. A year after the treatment, the bolts condition are examined and it shows they running well.

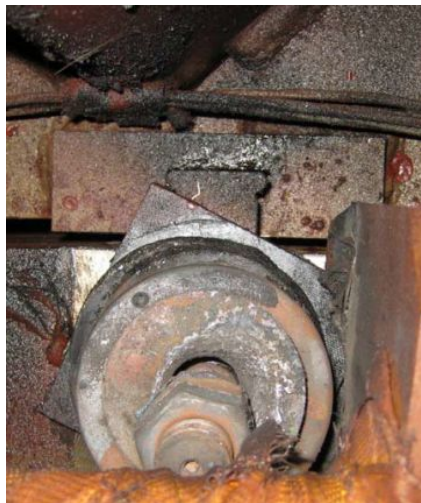
- 1) The melting bolts distribution has obvious pattern as they are opposing the key bars.
- 2) Leaked oil found on bolts
- 3) Some key bars are over heated.
- 4) Fracture is transverse fatigue fracture.

Fig 1. Melted key bar

- 1) Improve the bolt fixation to avoid 100Hz natural frequency.
- 2) Use thicker bolt insulation.
- 3) Fill the gap between the core and bolts with flexible material to minimize the vibration.
- 4) Improve the seal to reduce the oil mist.
- 5) Clean the oil mist regularly.

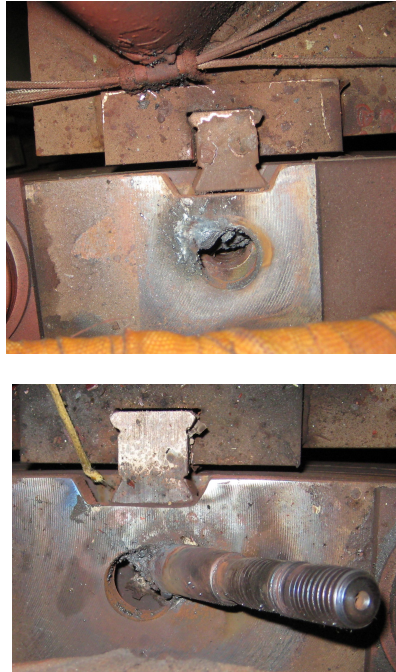
Fig 2. Melted through bolts

the eddy loss is about 3kW per bolt, and the loss density is about 22 times the stator coil value. The loss would make the bolts melt;

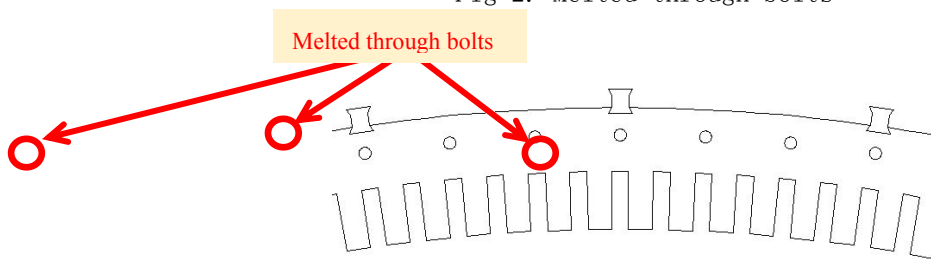
Fig 3. Melted key bars Distribution

- 3) The electromagnetic force is mainly 100Hz, 2.5kN per bolt.
- 4) The bolts near the key bars are more easily short circuited which the key bars. So they are more likely to melt and broke.

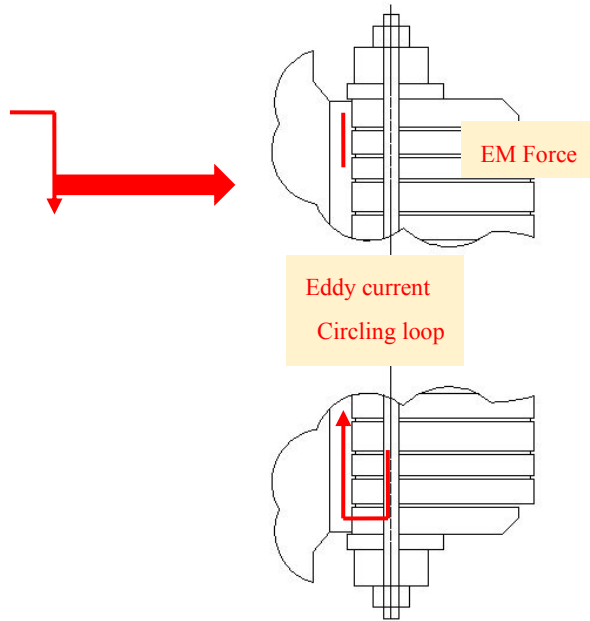
According to the investigation, it seems large force was applied to the damaged bolts. After operation for years, the fatigue fracture formed. At the meantime, large loss generated in the bolts and the bolts melted. The possibility is that after the through bolt insulation damaged, the through bolts were short circuited with the key bars at the back of stator core.

Fig 4. Short circuit passage

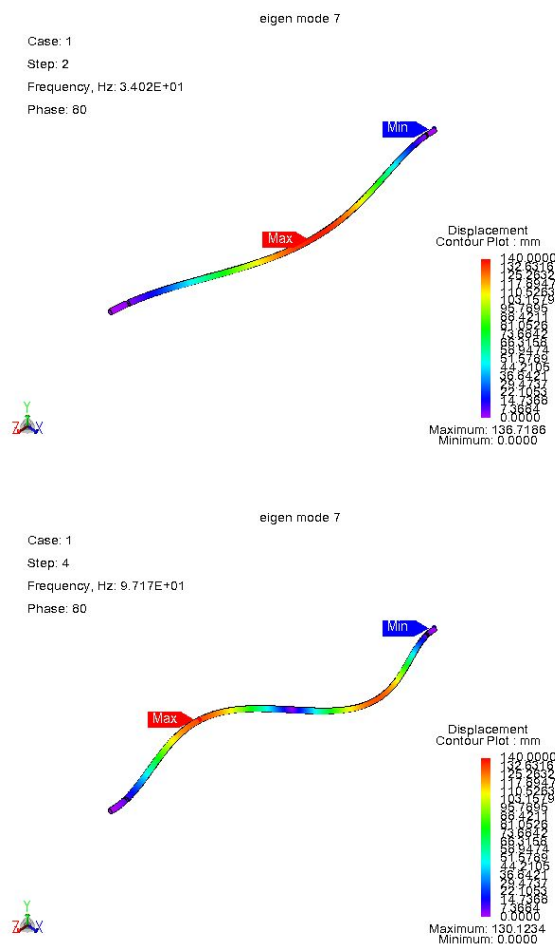
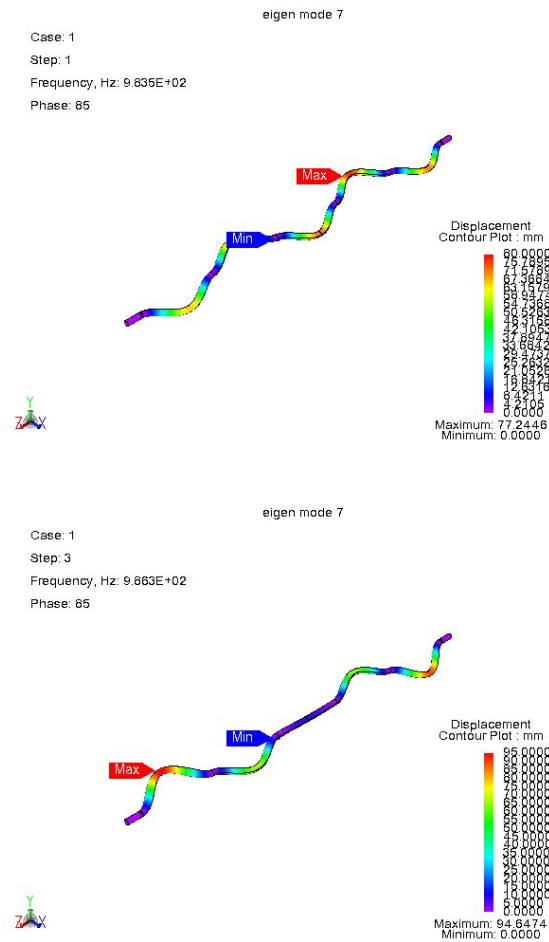
Tab.2 Modal Calculation Results of the Through Bolts

At first, the 2-support schemes is evaluated (means the bolts are fixed with the nuts at end part), the results show that the second order natural frequency is 97.2Hz. Based on the electromagnetic simulation, resonance will happen in the bolt.

Then, a 7-support schemes is evaluated (means except the end part fixation, the bolts are also fixed well with the core in active part), the results show that the natural frequency is higher than 983.5Hz, and it is far from the 100Hz, which is the EM force frequency.
